Manhole Inspection Summary

Manhole # S33S__035MH

Insp Date: 1/31/08 10:05 AM

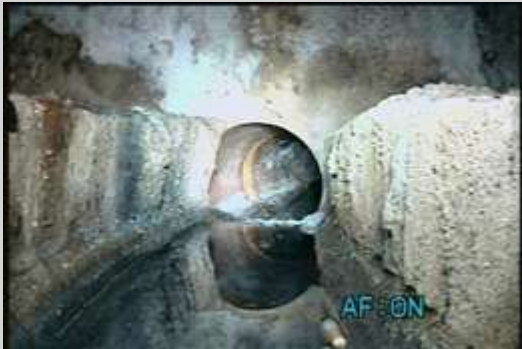
12 O'Clock Outflow

8 in. Circular Gravity Sewer
Pipe Out @ 12 O'Clock

Pipe Material: **Clay** ☐ Pipe Lined

Invert Depth: 9.10 (ft.) Flow Characteristics: **Slow**

Deposits: ☒ None ☐ Mud ☐ Sludge ☐ Debris ☐ Grease

Infiltration: **None** Pipe Seal Cond: **Unknown**

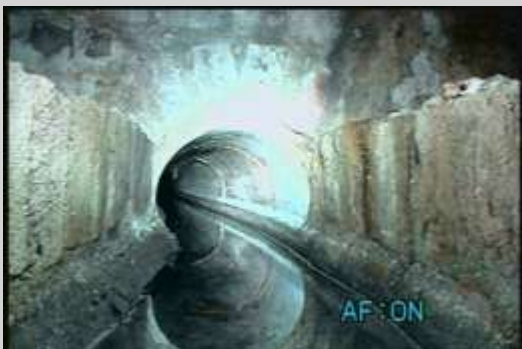
6 O'Clock Inflow

8 in. Circular Gravity Sewer
Pipe In @ 6 O'Clock

Pipe Material: **Clay** ☐ Pipe Lined

Invert Depth: 9.00 (ft.) Flow Characteristics: **Slow**

Deposits: ☒ None ☐ Mud ☐ Sludge ☐ Debris ☐ Grease

Infiltration: **None** Pipe Seal Cond: **Sound**
